# Insights into Unloading Relaxation Mechanism of Columnar Jointed Basalt at the Baihetan Left Dam Foundation

**2.1. Project Introduction.** The Baihetan Hydropower Station is located on the lower reaches of the Jinsha River, China, with its left bank on the side of Ningnan County in Sichuan Province and its right bank on the side of Qiaojia County in Yunnan Province. Its concrete dam, designed as a double-curvature arch format, is situated in an unsymmetrical V-shaped valley. The left dam foundation is a wide and gentle platform above 850 m in altitude, and steep and gentle slopes are alternately below 850 m; the right dam foundation is gentle slope terrain above 1170 m in altitude and steep slope below 1170 m [30, 31].

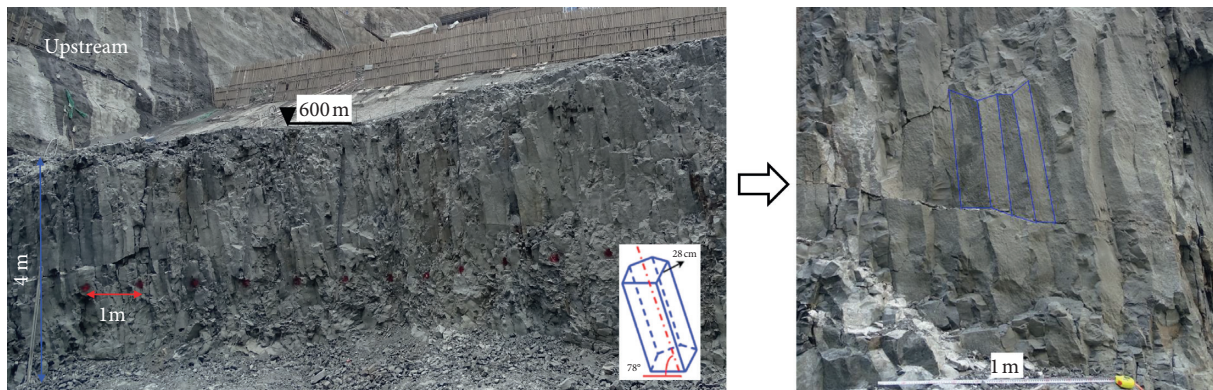
**2.3. Unloading Relaxation Failure of Columnar Jointed Basalt on Left Dam Foundation.** The CJB was widely exposed on the left dam foundation during excavation, located at below 670 m in altitude. The CJB is characterized by small columnar blocks with irregular polygons in cross-section, and the axis trends towards the valley with a dip angle of approximately 70°~85°. The intercolumnar joint surface is straight and rough at the decimeter scale, and the microfissures are developed in columns at the centimeter scale. The typical columnar joints revealed by excavation in the dam foundation are shown in Figure 2.

FIGURE 2: Typical CJB revealed at the left dam foundation.

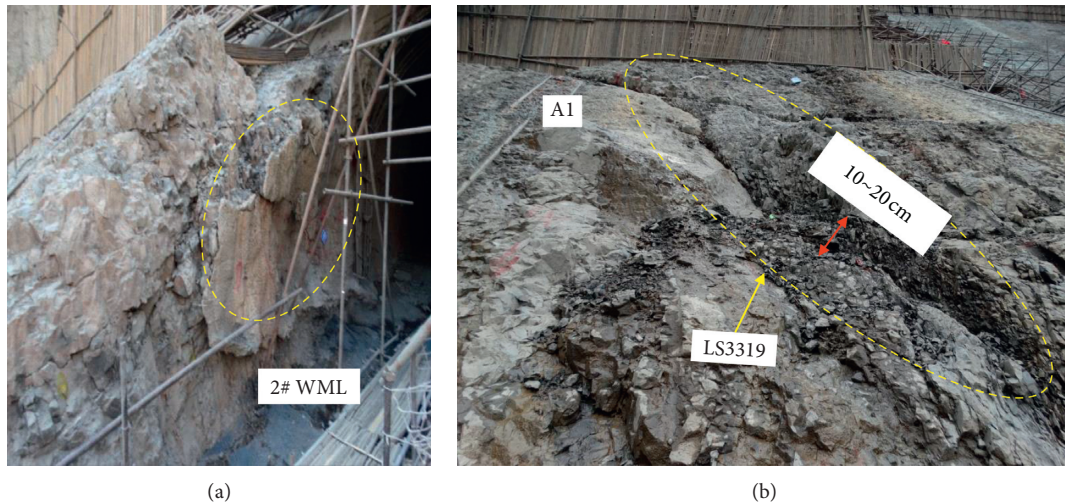
The field investigation showed that this exposed columnar jointed rock mass mainly exhibited two types of failure mode, such as joint opening and shearing dislocation. The shearing dislocation of columnar jointed rock mass may cause extra shearing deformation and even local collapse due to the reduced frictional resistance if no appropriate supporting measurements were applied, as shown in Figure 3(a). The opening of columnar jointed rock mass may cause the cracking of the intralayer dislocation zone LS3319 on the dam foundation, as shown in Figure 3(b).

FIGURE 3: Typical failure of CJB on the left dam foundation. (a) Shearing dislocation at 2# WML hole. (b) Relaxation of the intralayer dislocation zone LS3319.

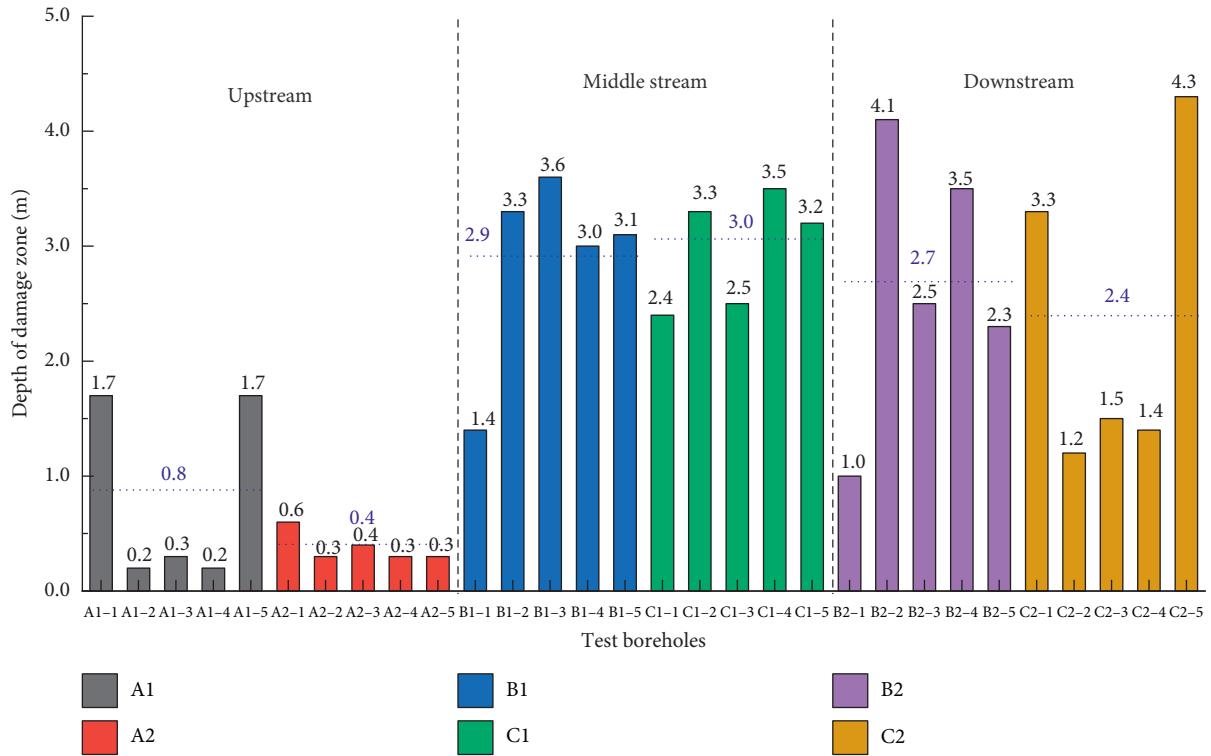
- (1) The relaxation depth of A zone on the upstream side of the dam foundation was between 0.2 and 1.7 m, with an average relaxation depth of 0.6 m; the relaxation depth of B1 zone in the middle of the dam foundation was between 1.4 and 3.6 m, with an average relaxation depth of 2.9 m; the relaxation depth of zone C1 was between 2.4 and 3.5 m, with an average relaxation depth of 3.0 m. The relaxation depth of B2 zone on the downstream side of the dam foundation was between 1.0 and 4.1 m, and with an average relaxation depth of 2.7 m; the relaxation depth of C2 zone was between 1.2 and 4.3 m, with an average relaxation depth of 2.4 m. In general, the relaxation depth of the columnar jointed basalt in the upstream of the dam foundation was minimum, the relaxation depth in the downstream of the dam foundation is middle, and the relaxation depth in the middle of the dam foundation is maximum, as shown in Table 1.

FIGURE 6: Total tested depths of EDZ in the CJB experimental zone (results at 8 months after excavation).

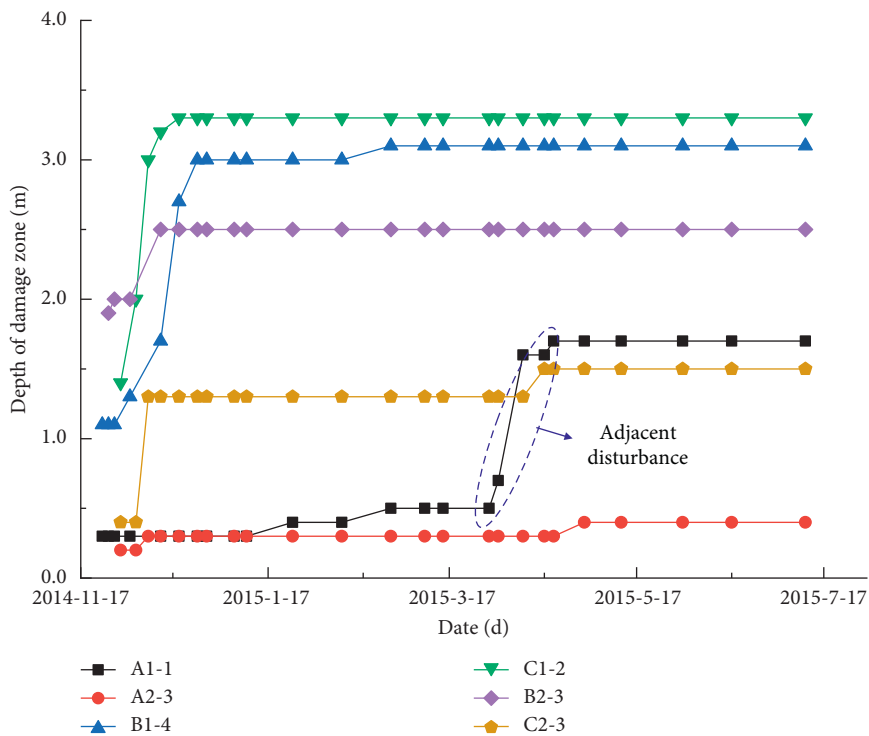
- (2) The unloading relaxation in upstream side of dam foundation (test zone A) is mainly caused by the unloading of the blasting excavation in this section, and the time-dependent relaxation effect is not obvious. The relaxation depth caused by excavation blasting accounts for more than 70% of the total relaxation depth. The specific relaxation depth time history evolution is shown in Figure 7; the time effect of the unloading relaxation in middle stream and downstream of dam foundation (test zone B and C) is more obvious, generally lasts about 45 days, and the initial relaxation depth caused by blasting accounts for 20~50% of the total relaxation depth, as shown in Figure 7.

FIGURE 7: Typical temporal evolution of the CJB damage depth.

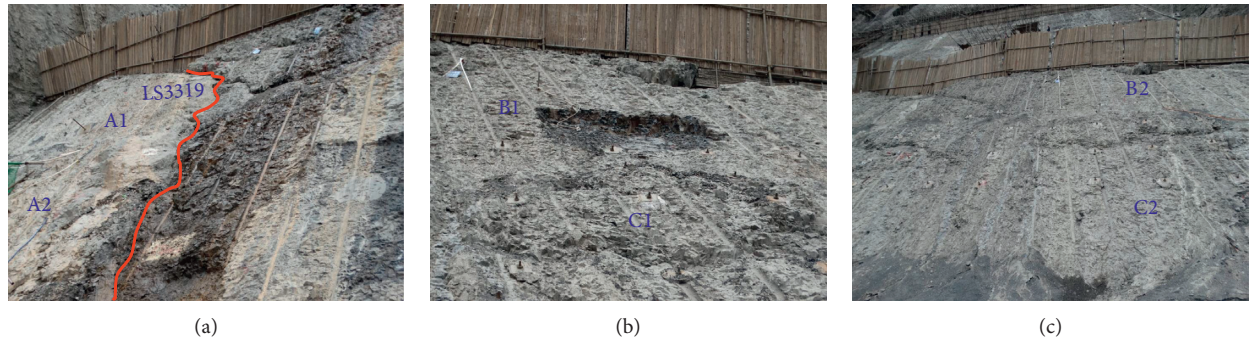
FIGURE 12: Outcropping rock mass on the surface of CJB test zone. (a) Fresh and intact rock mass, (b) weathered obviously rock mass, and (c) jointly developed rock mass.

that the CJB in A zone at the upstream side of the dam foundation is mostly III-1 rock mass, and the rock mass is usually compact, fresh, and complete, without weathering or weathering is not obvious. Most of the CJB in B1 and C1 zones at the middle stream of the dam foundation are III-2 rock mass. Compared with A zone, hidden joints are more developed and the rock mass is obviously weathered. In addition, although the CJB in B2 and C2 zones at the downstream side of the dam foundation is mostly III-1 rock mass, low-dip fractures and intra-bedded dislocation zones are relatively developed, as shown in Figure 12.

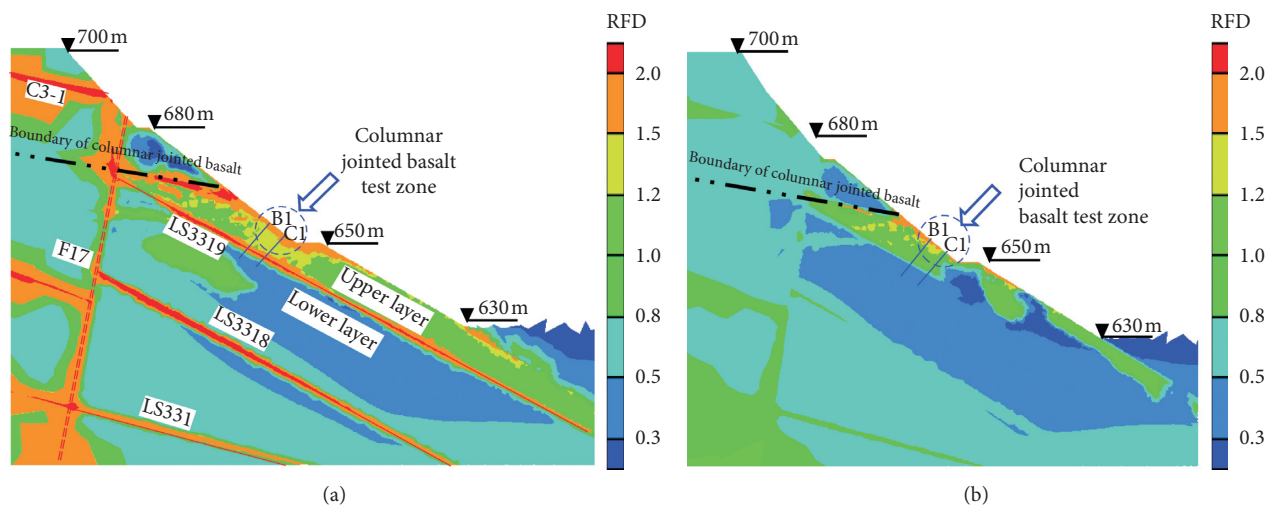
FIGURE 13: Influence of disadvantageous geological structure on unloading relaxation in the columnar jointed basalt test zone on left dam foundation. (a) With geological structure; (b) without geological structure.

*5.2. Influence of Disadvantageous Geological Structures on Unloading Relaxation of Columnar Jointed Basalt.* In order to study the effect of disadvantageous geological structure on the unloading relaxation of columnar jointed basalt, the numerical analysis of excavation unloading of dam foundation with and without disadvantageous geological structure is carried out in this paper. The results show as follows (Figure 13): (1) when the left dam foundation contains disadvantageous geological structures such as fault F7 and LS3319, the relaxation depth of the columnar jointed basalt test zone can reach 4~5 m, and the relaxation degree of the surface rock mass is greater; (2) when there is no unfavorable geological structure, the relaxation depth and relaxation degree decrease accordingly.

Serious relaxation failure occurred in the nearby rock mass due to the existence of disadvantageous geological structure, and the unload relaxation damage of CJB in the upper layer will be further aggravated. Field observation show that test zone A is located below dislocation zone LS3319, and test zones B and C are located above dislocation zone LS3319, and seriously slip dislocation was observed
