# Insights into Unloading Relaxation Mechanism of Columnar Jointed Basalt at the Baihetan Left Dam Foundation

**2.1. Project Introduction.** The Baihetan Hydropower Station is located on the lower reaches of the Jinsha River, China, with its left bank on the side of Ningnan County in Sichuan Province and its right bank on the side of Qiaojia County in Yunnan Province. Its concrete dam, designed as a double-curvature arch format, is situated in an unsymmetrical V-shaped valley. The left dam foundation is a wide and gentle platform above 850 m in altitude, and steep and gentle slopes are alternately below 850 m; the right dam foundation is gentle slope terrain above 1170 m in altitude and steep slope below 1170 m [30, 31].

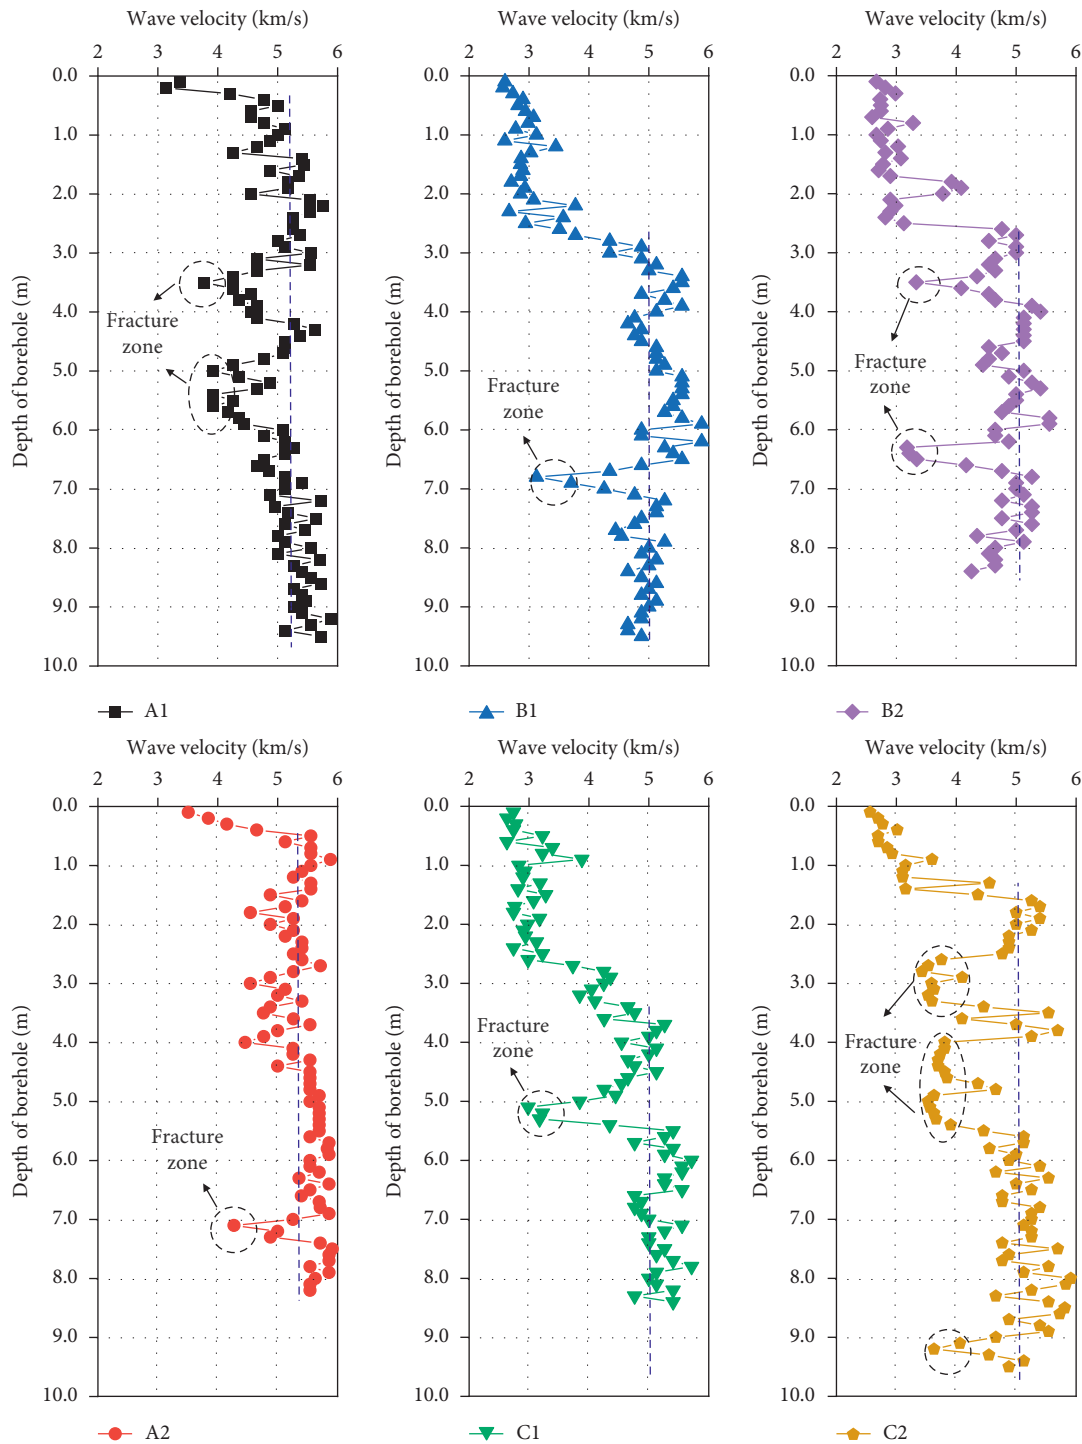
FIGURE 5: Typical tested P wave velocity vs. depth in the boreholes (1 month after excavation).

calculated in the unrelaxed rock mass. In situ tests by the ultrasonic P wave apparatus showed as follows (Figure 5):

- (1) On the upstream side of the dam foundation, the average P wave velocity of the unrelaxed CJB was approximately 5186 m/s, but that of the damaged columnar jointed rock mass was 3150 m/s in average in subzone A1, and the average P wave velocity of the unrelaxed CJB was approximately 5249 m/s, but that of the damaged columnar jointed rock mass was 3284 m/s in average in subzone A2.
- (2) On the middle stream side of the dam foundation, the average P wave velocity of the unrelaxed CJB was approximately 4962 m/s, but that of the damaged columnar jointed rock mass was 2844 m/s in average in subzone B1, and the average P wave velocity of the unrelaxed CJB was approximately 4946 m/s, but that of the damaged columnar jointed rock mass was 2874 m/s in average in subzone C1.
- (3) On the downstream side of the dam foundation, the average P wave velocity of the unrelaxed CJB was

approximately 5070 m/s, but that of the damaged columnar jointed rock mass was 2988 m/s in average in subzone B2, and the average P wave velocity of the unrelaxed CJB was approximately 5045 m/s, but that of the damaged columnar jointed rock mass was 2980 m/s in average in subzone C2.

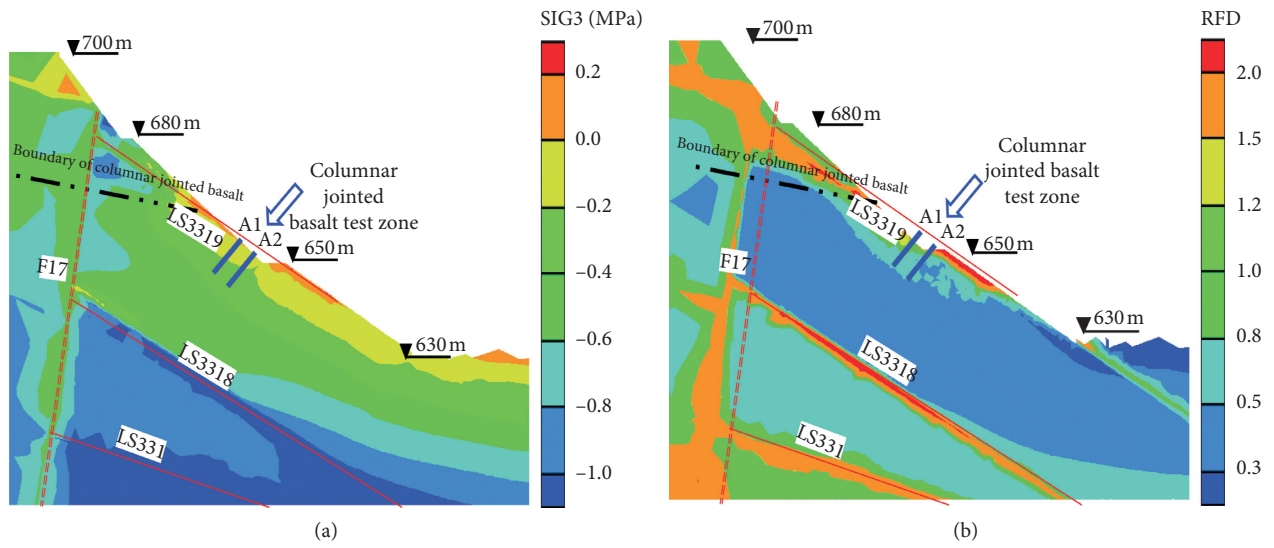
FIGURE 9: Unloading relaxation characteristics of CJB on the upstream side of the left dam foundation (A1 and A2 zones). (a) Minimum principal stress; (b) rock failure zone RFD.

- (2) After the excavation of the left dam foundation, the surface of the dam foundation is damaged by unloading relaxation, especially in the CJB section, and the damage is obvious. The results of numerical analysis show that the relaxation depth of the columnar jointed basalt test zone is small in the upstream, generally about 1 m (Figure 9), the largest in the middle, averaging 3~4 m, up to 5 m locally (Figure 10), and the relaxation depth of the downstream of the dam foundation is 2~3 m on average (Figure 11). The RFD value on the surface of the dam foundation is greater than 1.5, which means that unloading relaxation of the CJB in this region seriously.

around LS3319. The unloading relaxation damage of CJB in test zones B and C will be seriously affected by the dislocation zone LS3319, as shown in Figures 9–11.

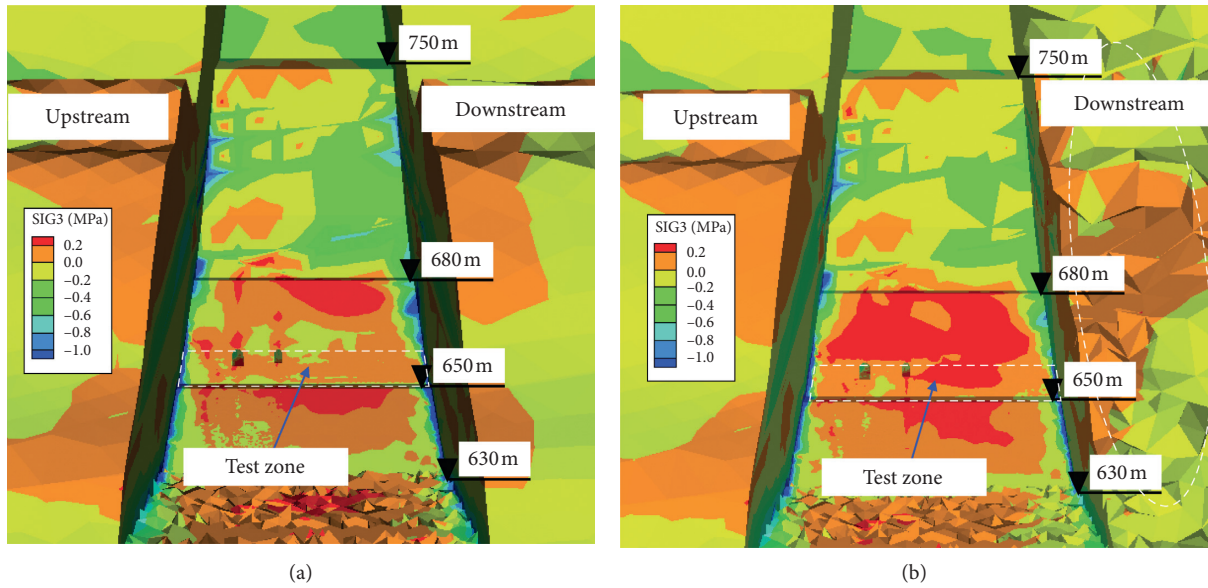
FIGURE 14: Influence of excavation of downstream abutment on minimum principal stress distribution on left dam foundation. (a) Unexcavated downstream abutment; (b) excavated downstream abutment.

The calculation results indicated that (1) with the excavation of downstream abutment, the range of stress release zone and damage zone was further enlarged and (2) with the excavation of the downstream abutment, the range of stress release zone and damage zone in the columnar jointed basalt on the dam foundation was shifted from upstream to downstream (Figures 14 and 15).
