Research Article

Exploration and Research on the Propagation Law of Seepage Risk Network in Tailings Storage Facility

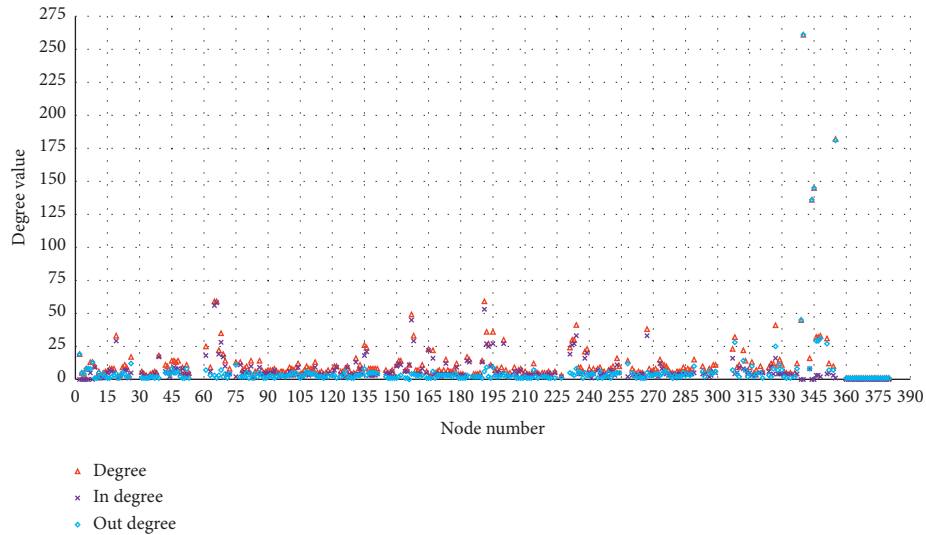
FIGURE 4: Node degree in the PNSRTP.

4.2.1. Degree Values and Degree Distribution. The degree values of each node in the PNSRTP are shown in Figure 4. The degree value of the seepage hazard node is an important index to reflect the influence of hazards. According to the different directions of the relationship between hazards, it can be divided into out degree and in degree. Through the

As can be seen from Figure 4, the node with the largest degree is 340 (insufficient safety supervision), which can directly affect 261 kinds of hazards. 355 (lack of qualification and experience of personnel and institutions) belongs to the personnel system, which is the second largest hazard (182). The degree values of 345 (defects of safety production rules and regulations and operation procedures) and 344 (outdated specifications and standards for survey, design, construction, and acceptance) are 145 and 136, respectively. The degree values of 65 (dam deformation), 66 (dam crack), and 191 (drainage structure fracture) are all 59, of which 65 and 66 belong to the dam system and 191 belongs to the drainage system. 157 (filter water failure) also belongs to the dam system, for which the degree value is 49. The degree value of 339 (insufficient capital input) is 45, which belongs to the

management system with hazards 340, 344, and 345, which highlights that the management factor plays a vital role in the safety management of the tailings seepage system. The degree value of 234 (blockage or siltation) is 41, which is the smallest hazard in the top ten hazards and also the only hazard belonging to the conveying system. It shows that the conveying system also has a certain impact on the seepage of tailings pond.

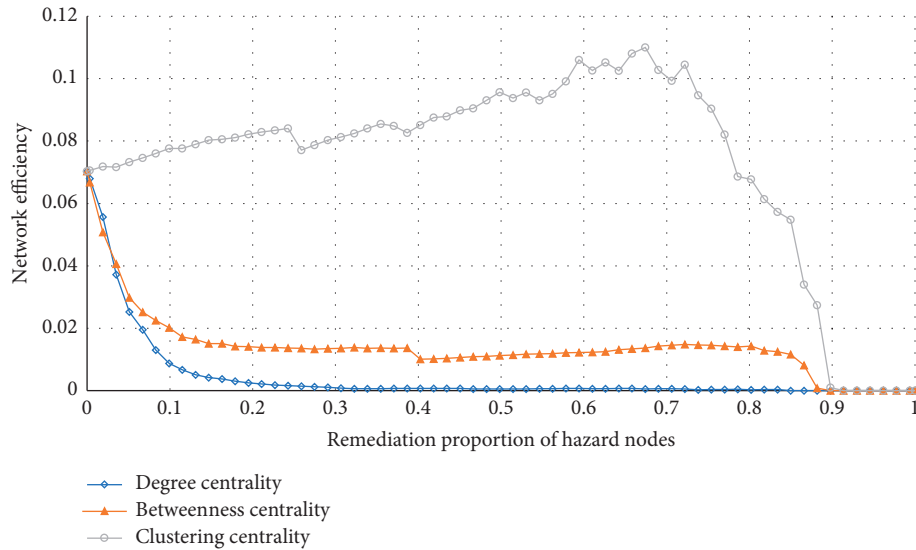
FIGURE 9: The change of the network efficiency of the PNSRTP.

In order to verify which one of the three indicators can reduce the global efficiency of the network more quickly and effectively, that is, to reduce the spread of seepage risk, according to the order (size) of the index value, the hazard nodes are treated (deleted) in turn in this paper and then the global efficiency of the network after treatment is calculated. In the management of hazard nodes, the hazard node with the largest index value is treated for the first time and then 5 hazards are treated at a time according to the order of index values, until all hazards are treated. The decline of the network efficiency of the PNSRTP under the three hazard remediation methods is shown in Figure 9.

As can be seen from Figure 9, after the hazard of high clustering coefficient is treated, the network efficiency cannot decline rapidly. Even when the node deletion ratio is less than about 70%, the network efficiency shows an increasing trend. Therefore, the nodes with a large clustering coefficient are not suitable for priority governance. Both betweenness centrality and degree centrality can quickly reduce the network efficiency of the PNSRTP, but obviously, the effect of degree centrality is better. When the ratio of hazard treatment is less than 5%, the two indexes have the same effect on the reduction of seepage risk and even the betweenness centrality is slightly dominant. However, with the increase in remediation proportion, the gap between the two began to increase. When the governance ratio reaches about 30%, the network efficiency of the PNSRTP is quickly reduced to around 0 under the degree centrality, while the network efficiency is maintained between 0.1 and 0.15 under the betweenness centrality. Therefore, in the prevention and control of tailings pond seepage risk, we should select degree centrality as the index to measure the importance of nodes and give priority to the nodes with large degree value.
